# **From Dental Composites to Degraded MLI:**

Selected short stories from the  
world of a Materials Engineer

# **COS Interpoint DC-DC Power Converter Failure in Vacuum**

# **HST SM4**

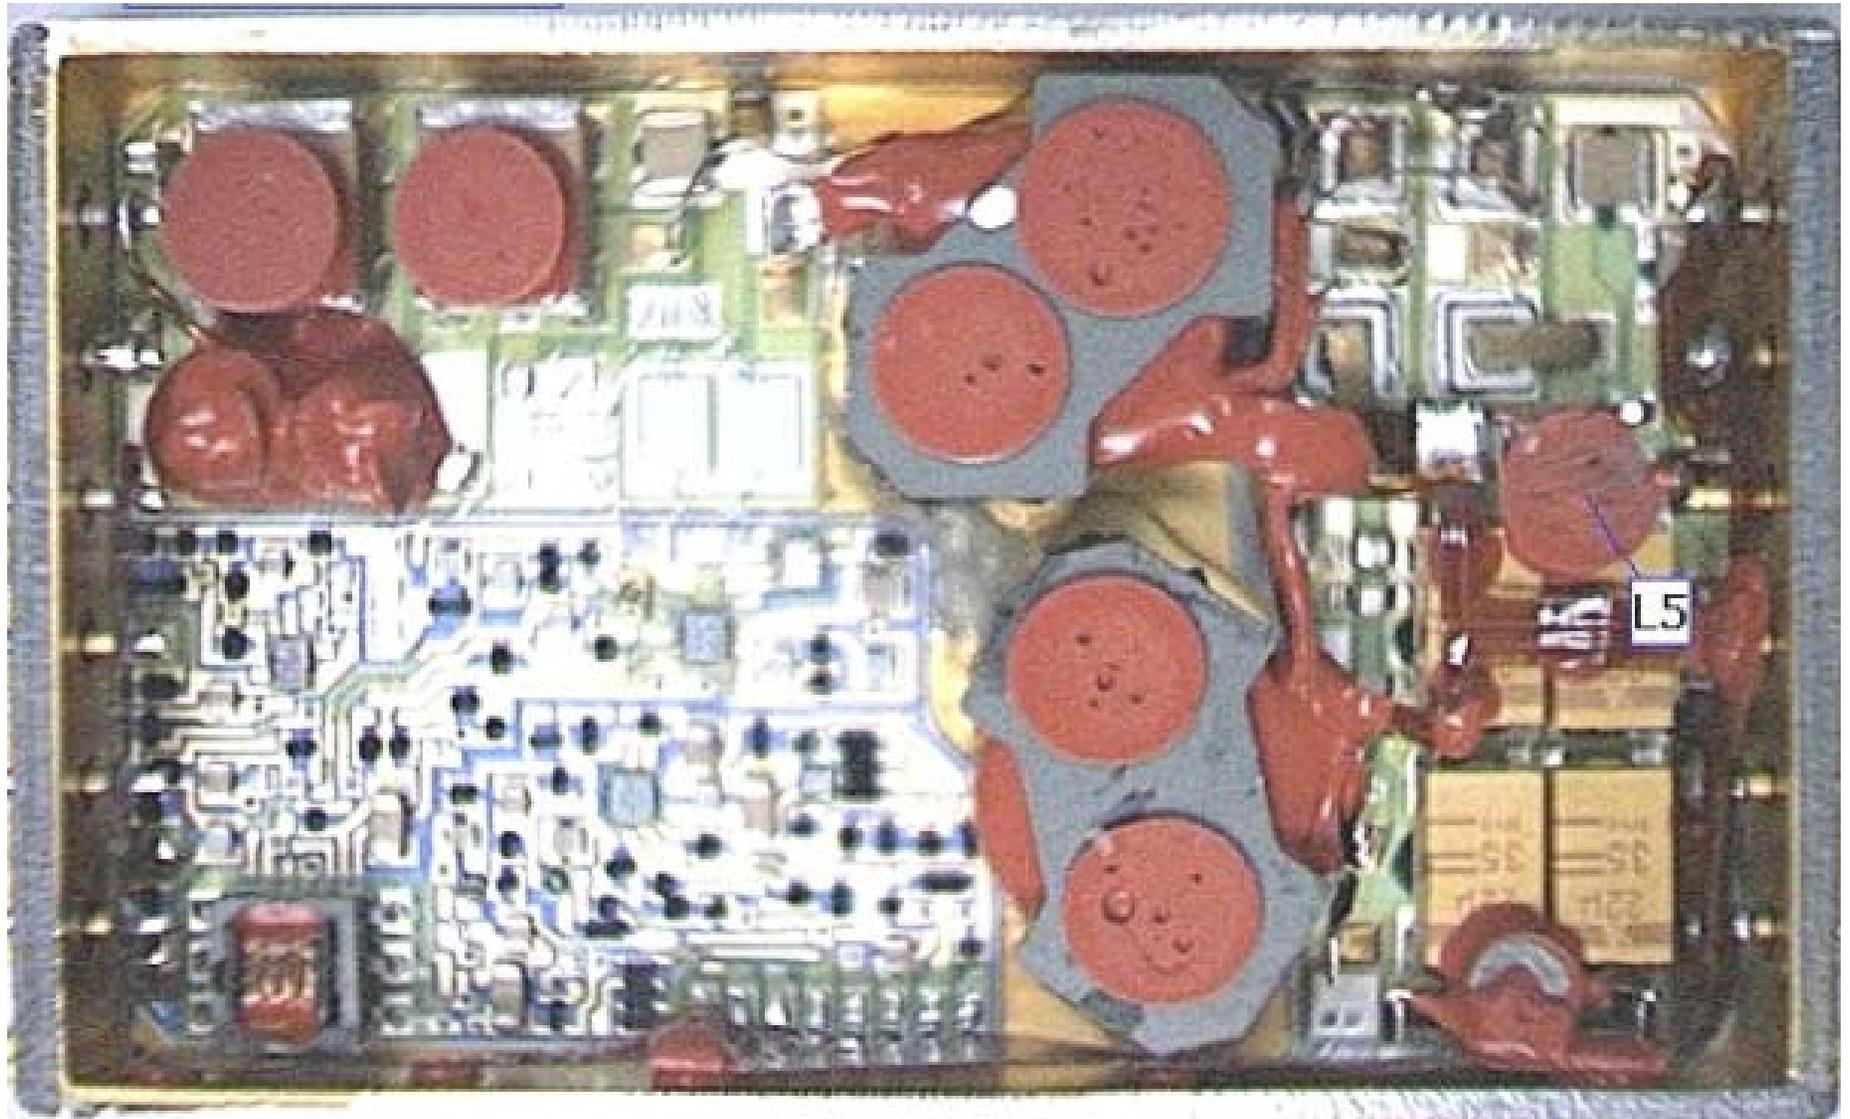
# MFL2815D with Lid Removed

- A halo was observed around the ‘foot’ of the L5A inductor lead.
- The converter was then installed in a vacuum bell jar, mounted to the real time radiography manipulation stage, and configured with continuous impedance monitoring of the -15V output.
- This allowed realtime telemetry of the circuit resistance while observing any internal movement as a function of external pressure.
- BTW, Interpoint power converters are hermetically sealed with ambient pressure inside.

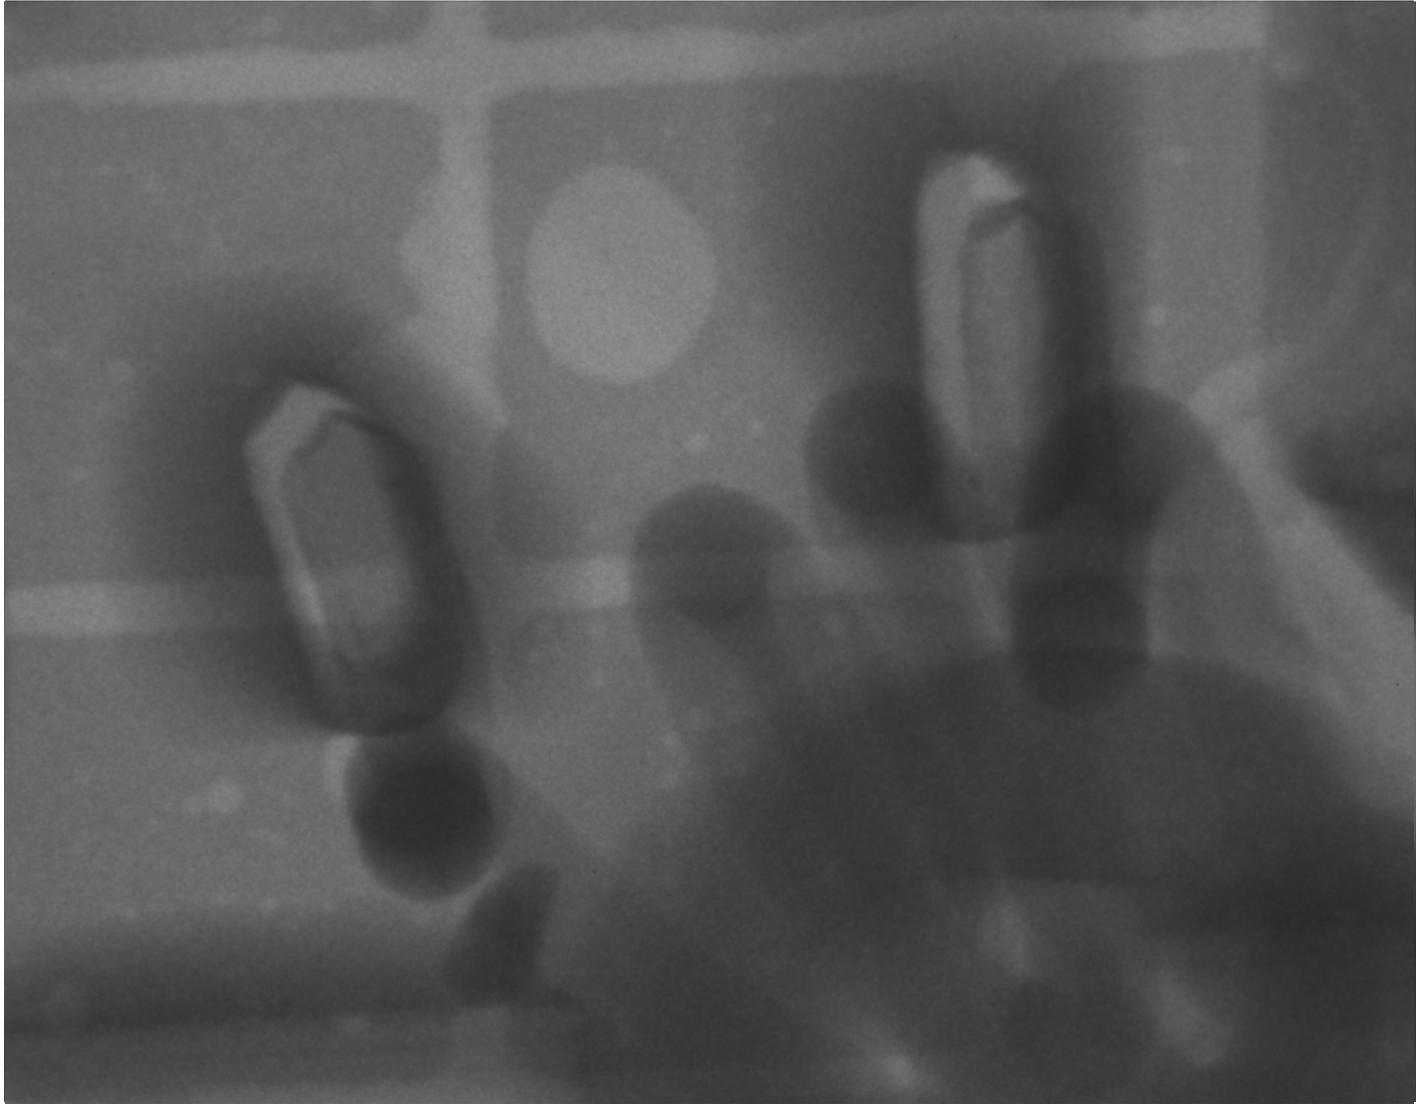
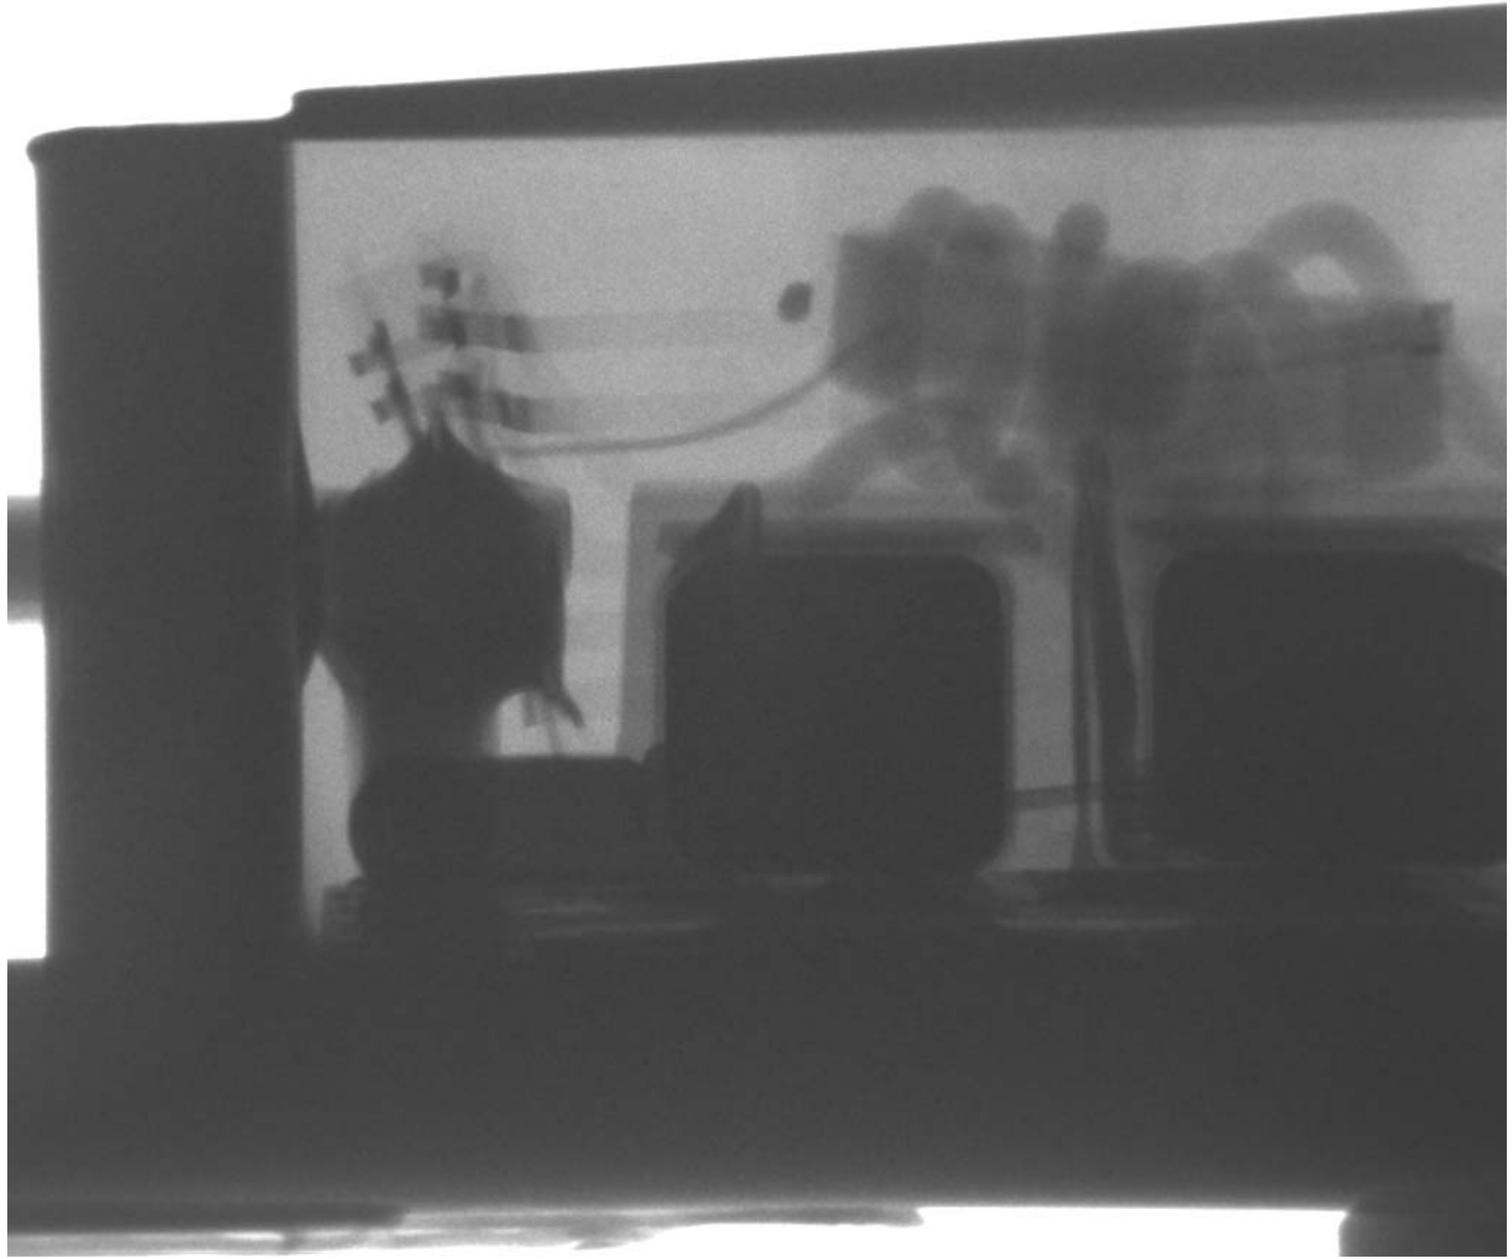
L5A

- Detrimental combination of:
  - L5 inductor bonded to lid
  - lid bowing outward upon vacuum acquisition
  - lack of adequate strain relief of L5 leads

- All dual power converters, on all PWAs, were radiographed to assess the inductor strain relief.
- Subsequently, Kovar plates were bonded to the lids to stiffen and thereby minimize deflection.
- For unrelated reasons, all Interpoint power converters were removed and replaced.

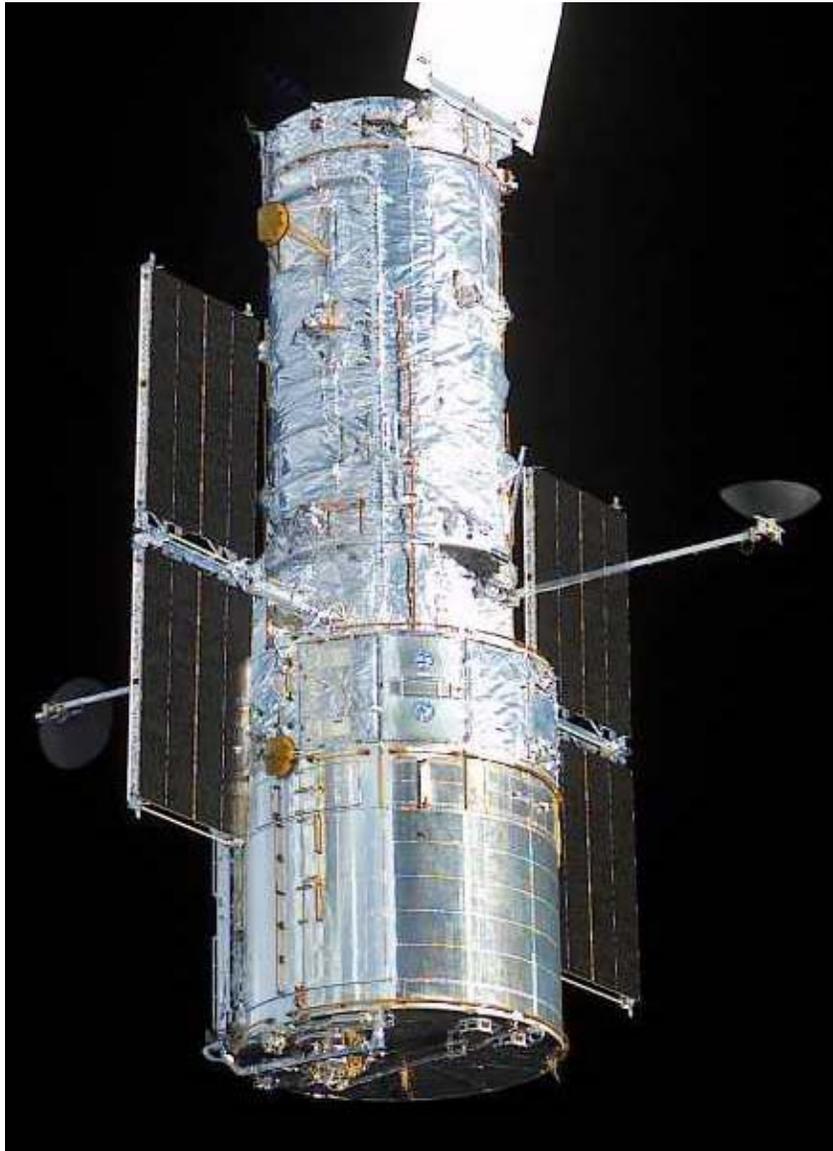
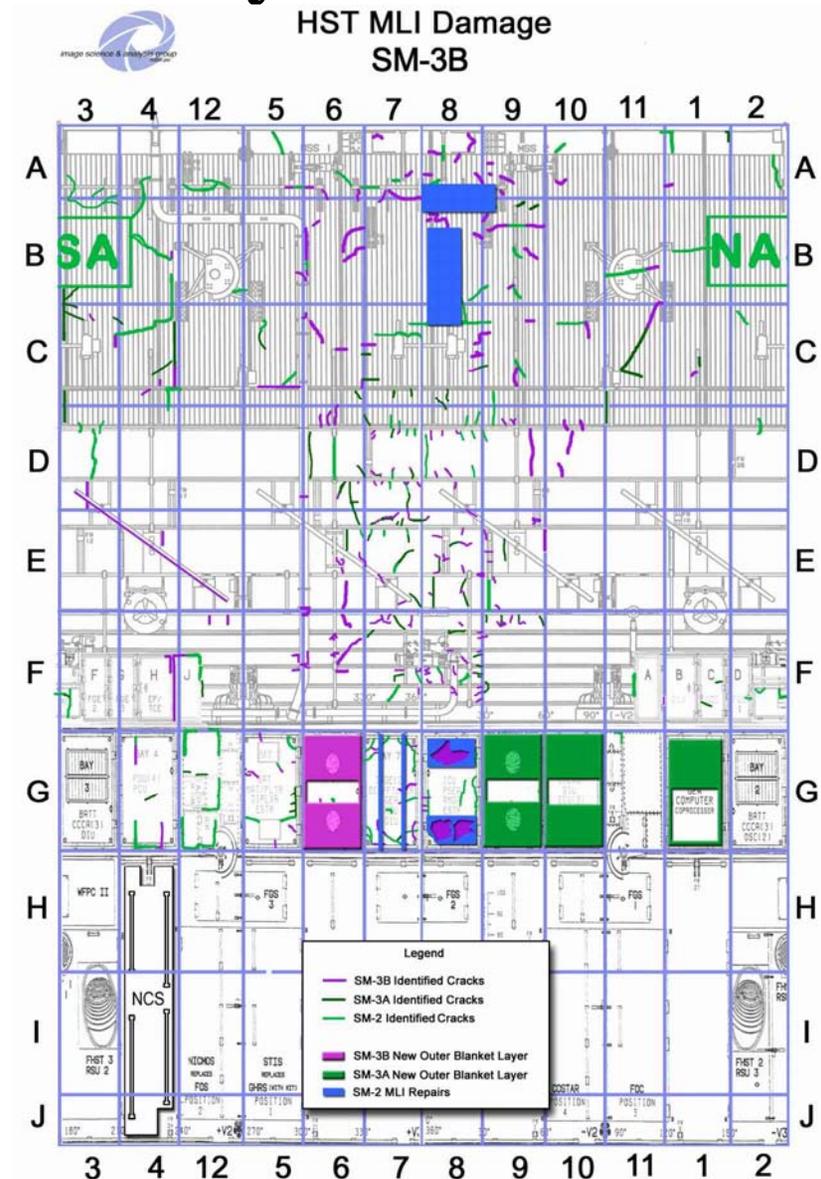
# HST Damage Map as of Mar 2002

- SM2 96 cracks all 5 inches or longer (light green)
- SM3A 150 total cracks, 9 existing much longer (dark green)
- SM3B 260 total cracks, 38 existing grew longer (violet)
  - 75% of cracks are on +V3

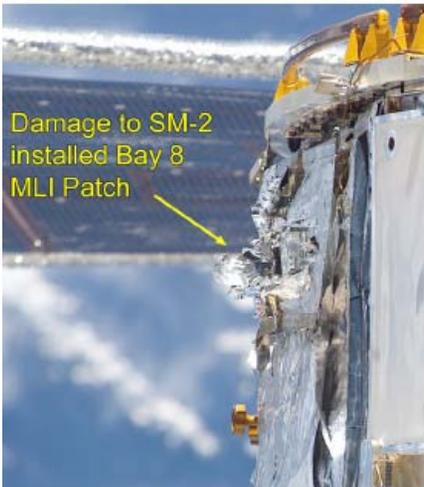
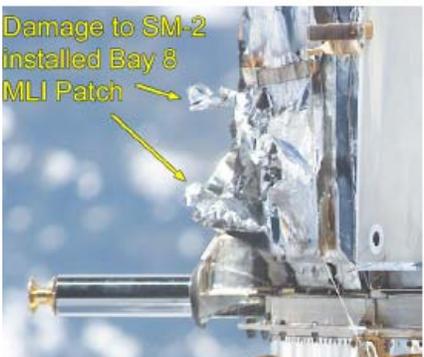
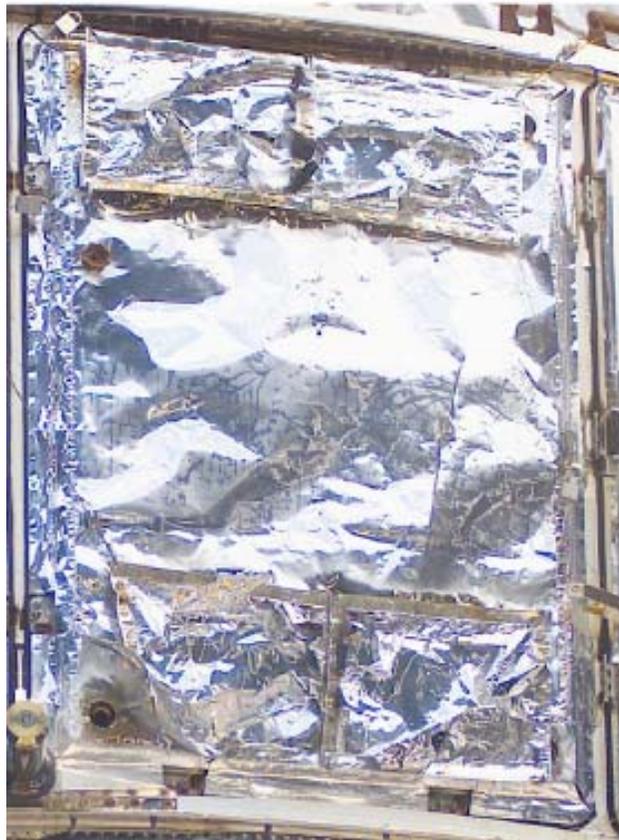
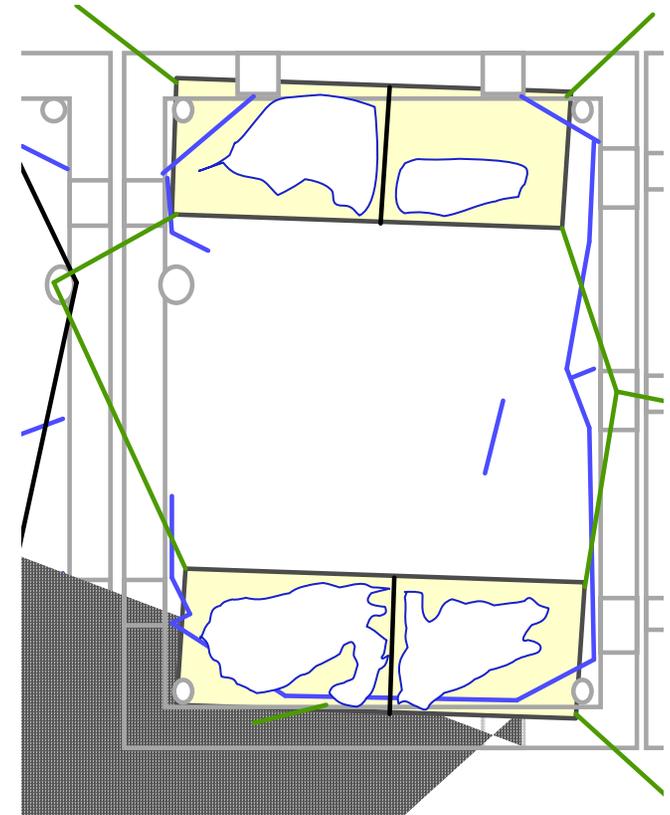
# Bay 8 Details

- Original 17 layer MLI on Bay door cracked but in place
- Patches installed Feb 1997 - single layer 2 mil FEP Teflon aluminized
- Electronic equipment inside at risk of exceeding upper temp limit
- Patches & MLI to be removed and replaced with a NOBL

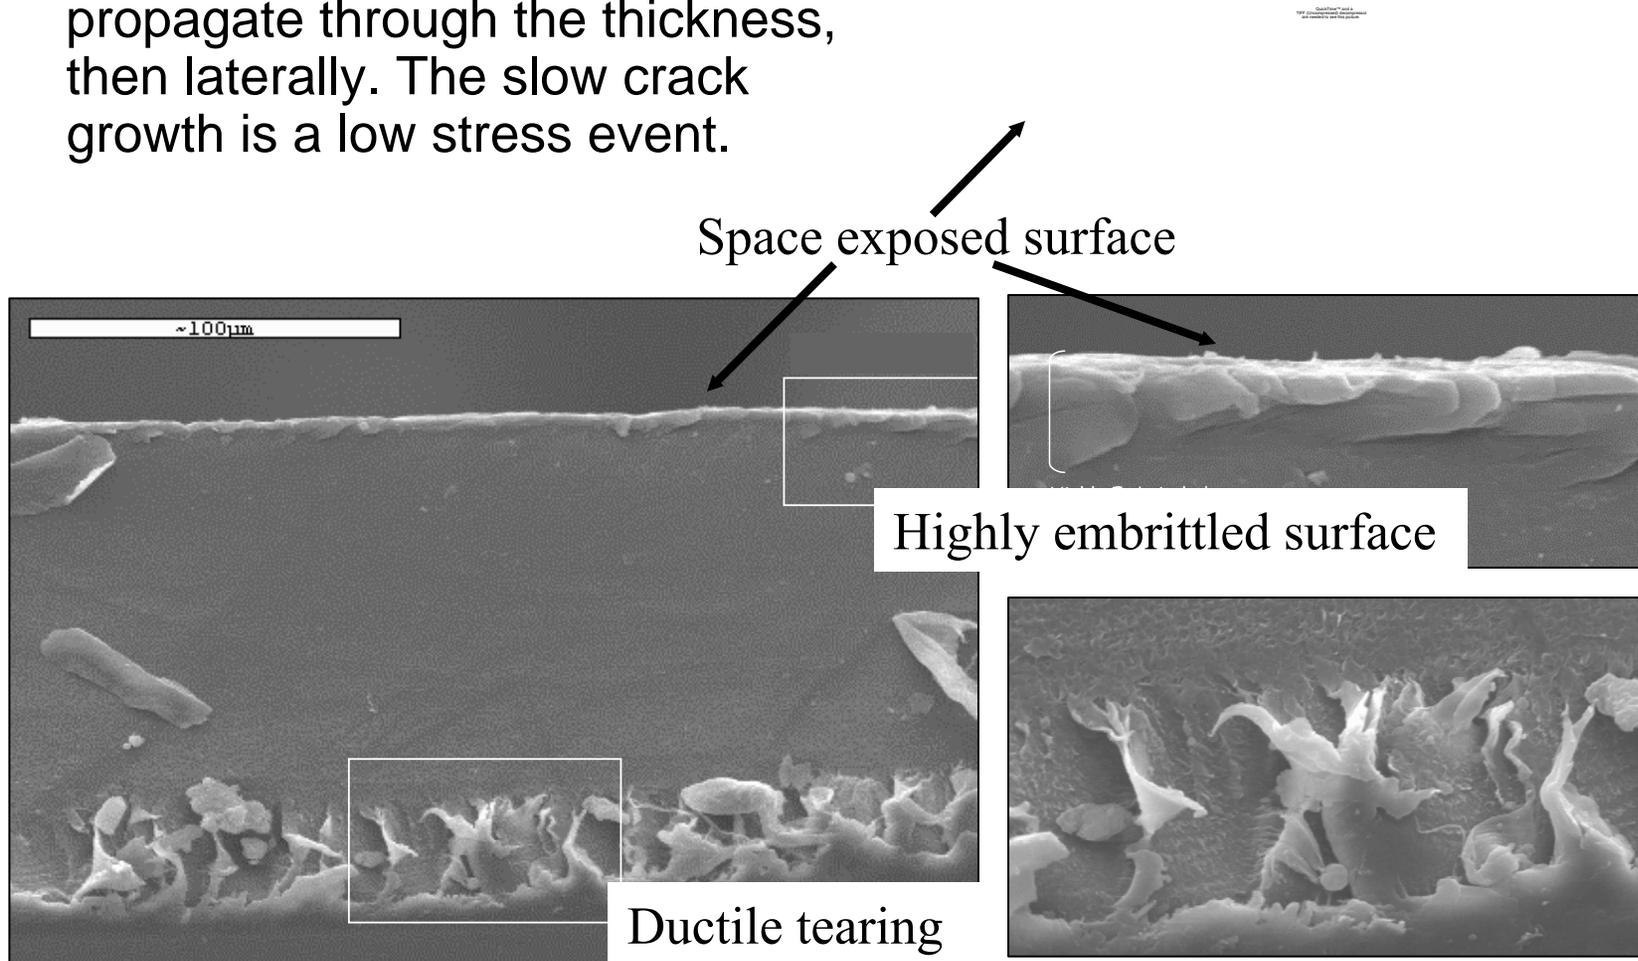
# SEM images of 5 mil Teflon 9.8 years exposure

- Cracks initiate on the space exposed, embrittled, side-propagate through the thickness, then laterally. The slow crack growth is a low stress event.

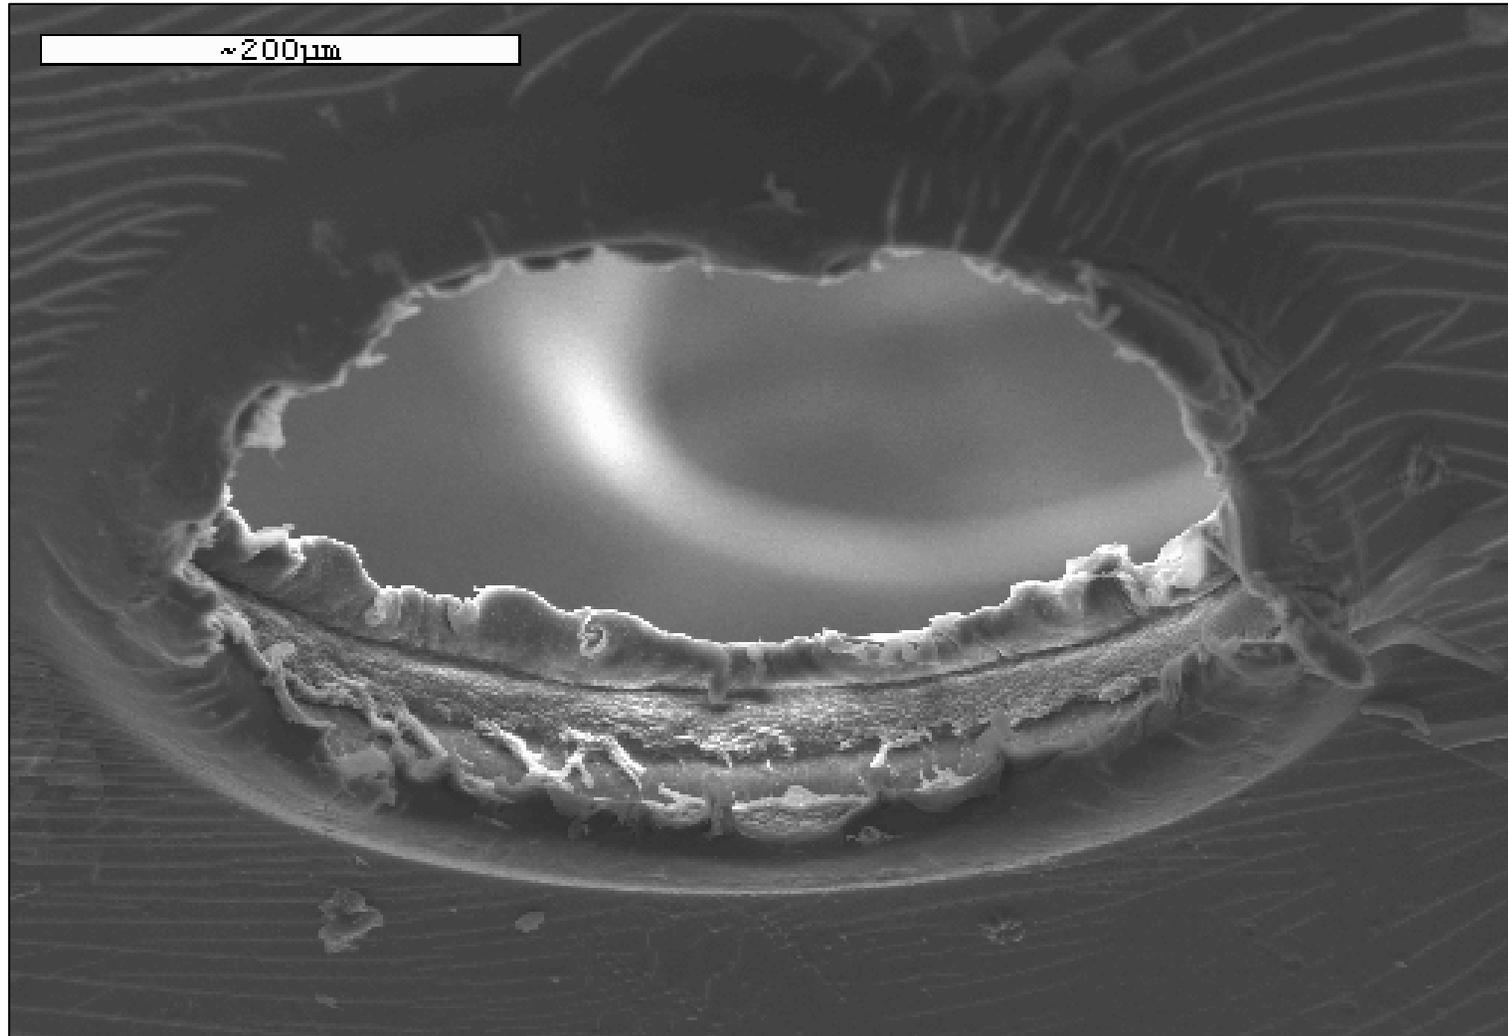
# Detail of a Through-Hole

- Impact Site
- Through hole
