# **From Dental Composites to Degraded MLI:**

Selected short stories from the  
world of a Materials Engineer

# **COS Interpoint DC-DC Power Converter Failure in Vacuum**

# **HST SM4**

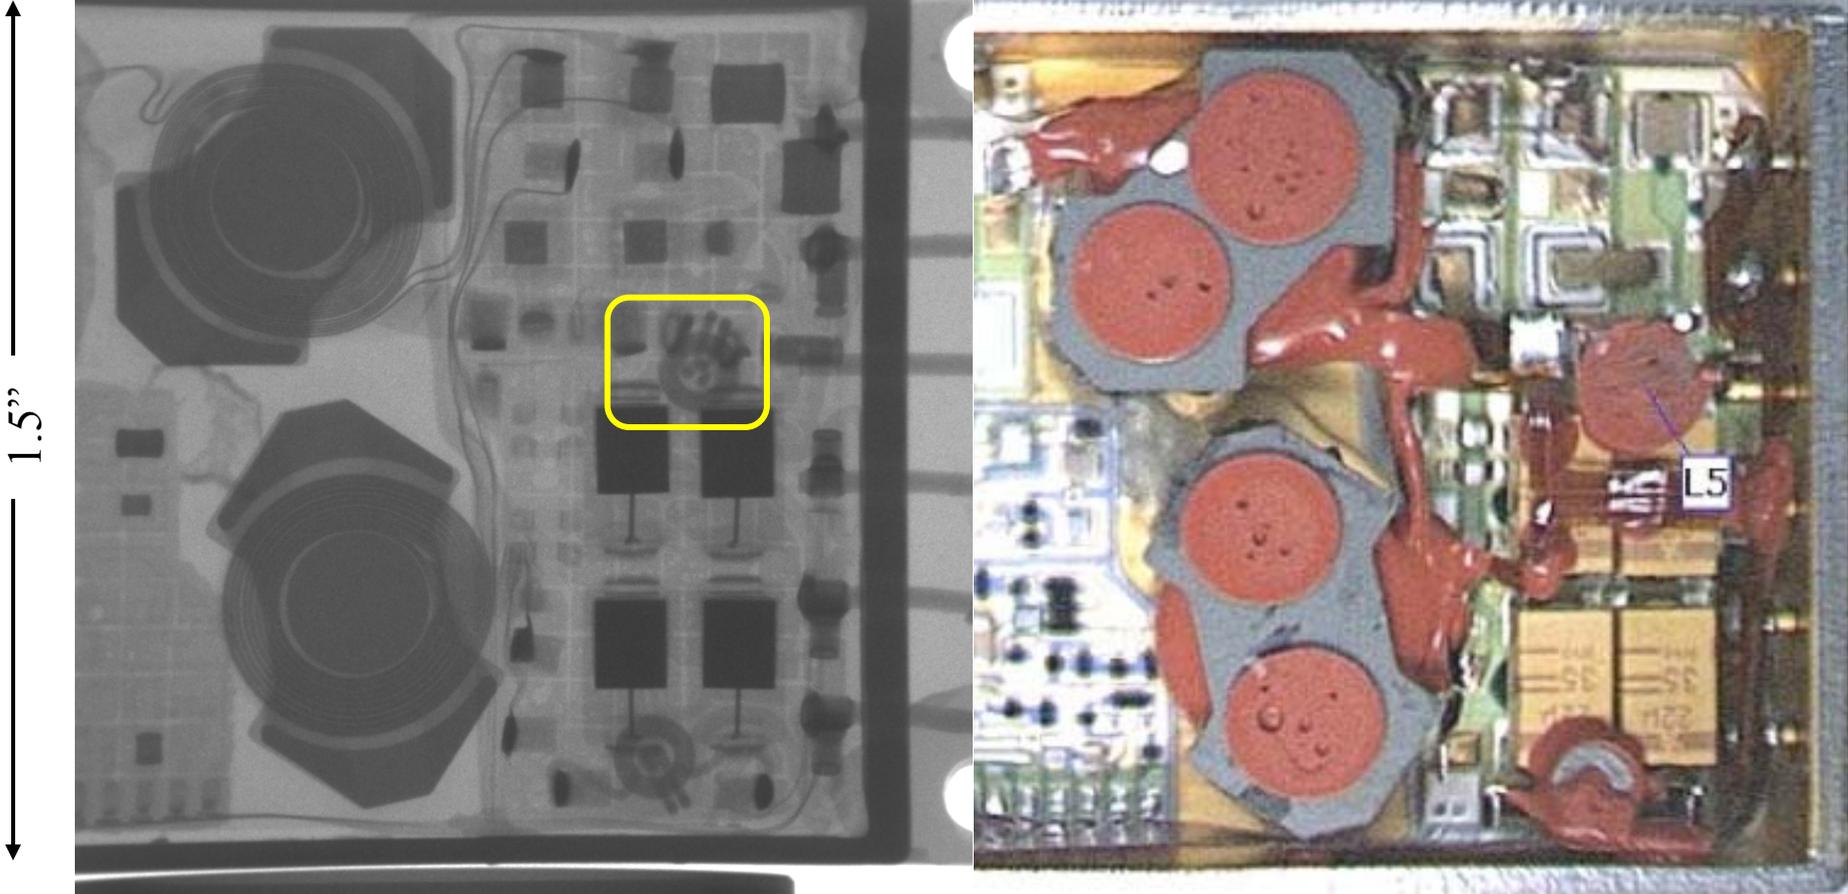
# Internals of Interpoint 2815D, LDC 9846

- A halo was observed around the ‘foot’ of the L5A inductor lead.
- The converter was then installed in a vacuum bell jar, mounted to the real time radiography manipulation stage, and configured with continuous impedance monitoring of the -15V output.
- This allowed realtime telemetry of the circuit resistance while observing any internal movement as a function of external pressure.
- BTW, Interpoint power converters are hermetically sealed with ambient pressure inside.

- Detrimental combination of:
  - L5 inductor bonded to lid
  - lid bowing outward upon vacuum acquisition
  - lack of adequate strain relief of L5 leads

- All dual power converters, on all PWAs, were radiographed to assess the inductor strain relief.
- Subsequently, Kovar plates were bonded to the lids to stiffen and thereby minimize deflection.
- For unrelated reasons, all Interpoint power converters were removed and replaced.

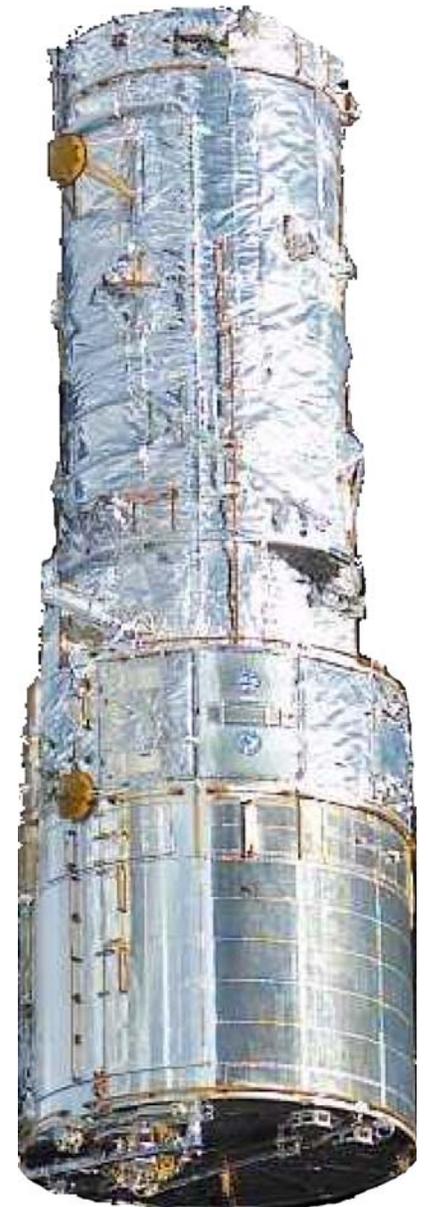
# HST Damage Map as of Mar 2002

## JSC ISAG Survey

# Damage Map Summary

- SM2 96 cracks all 5 inches or longer (light green)
- SM3A 150 total cracks, 9 existing much longer (dark green)
- SM3B 260 total cracks, 38 existing grew longer (violet)
  - 75% of cracks are on +V3

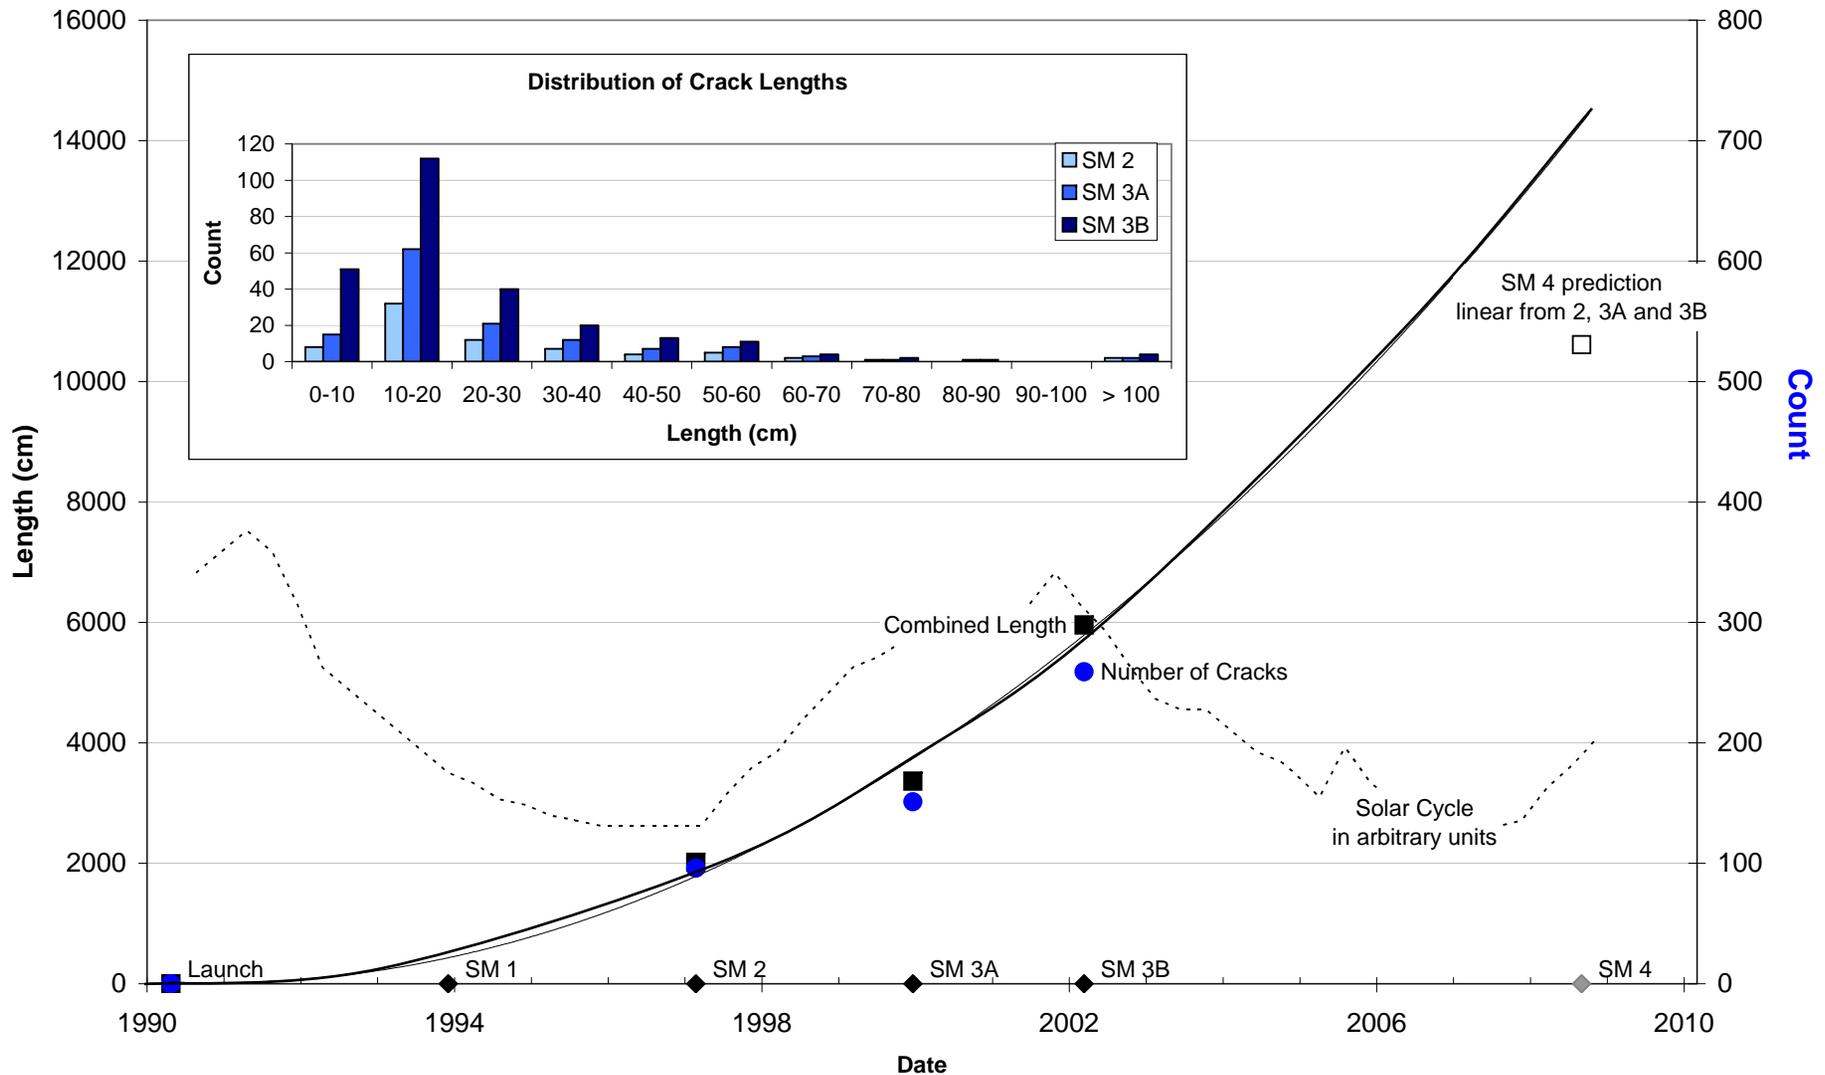
# SM4 MLI Crack Prediction

Hundreds of new cracks; average length 20 cm; a few much larger cracks

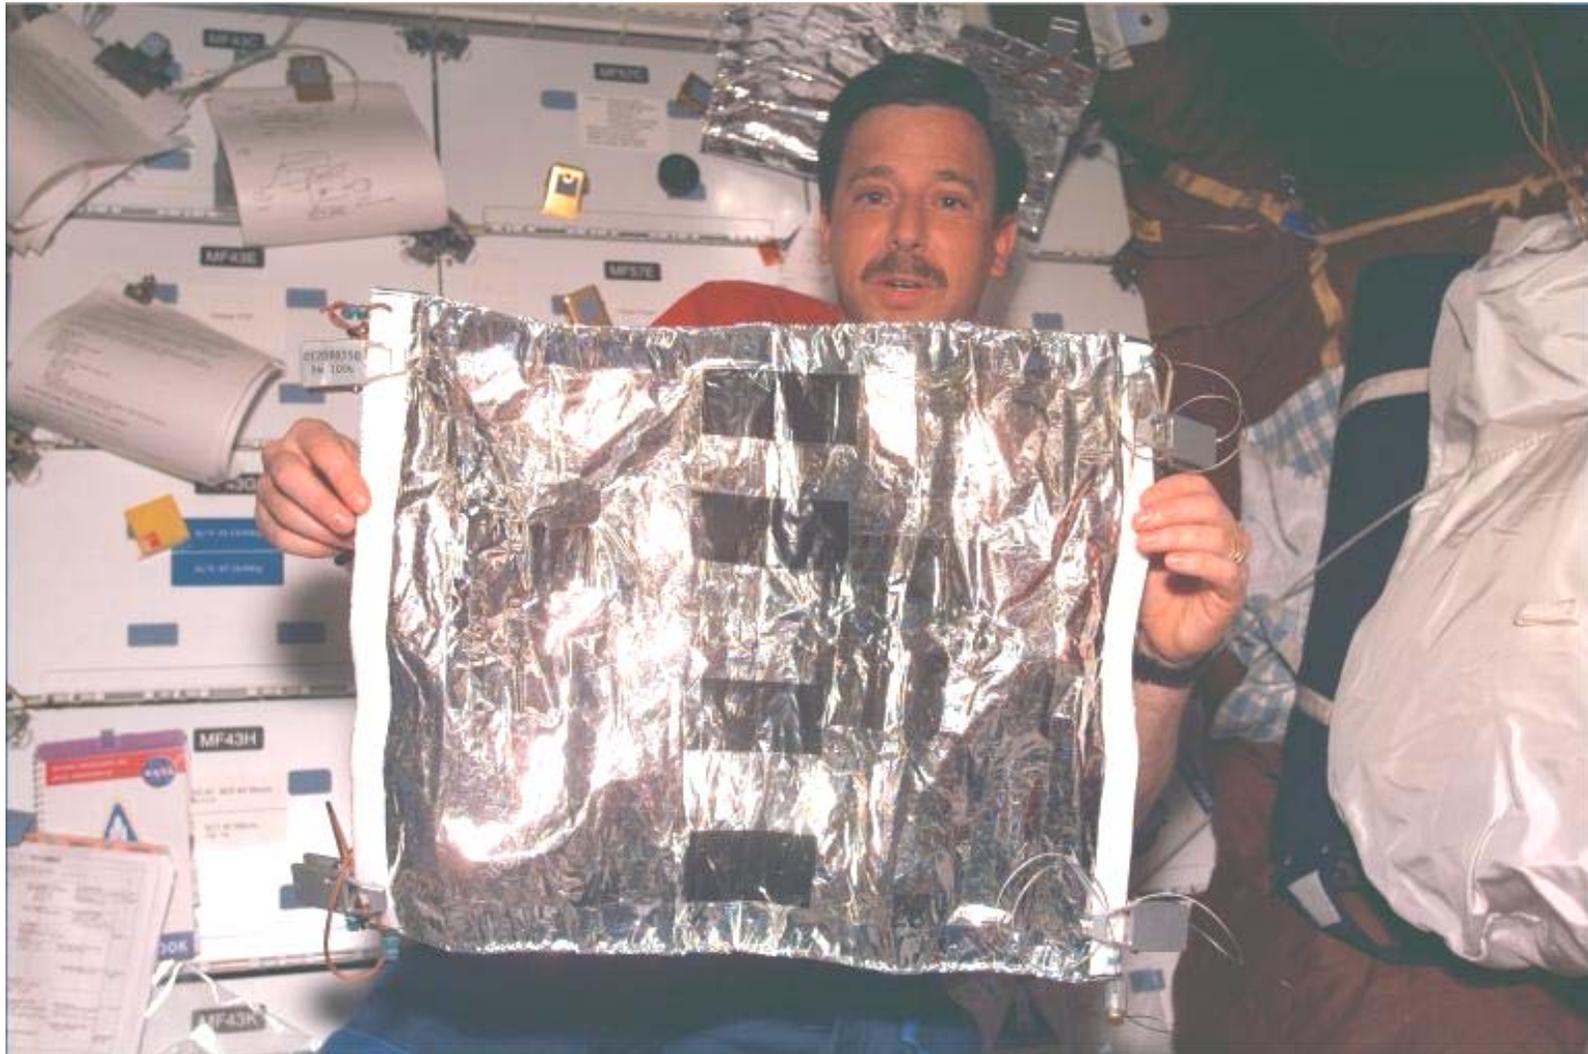
# Bay 10 Patch Prior to Installation

S82E5689 1997:02:17 14:47:50

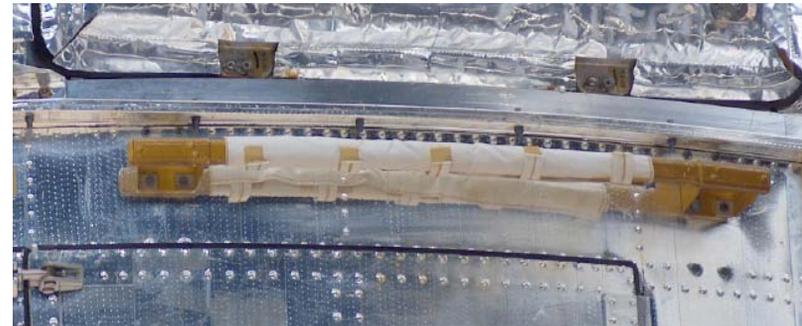
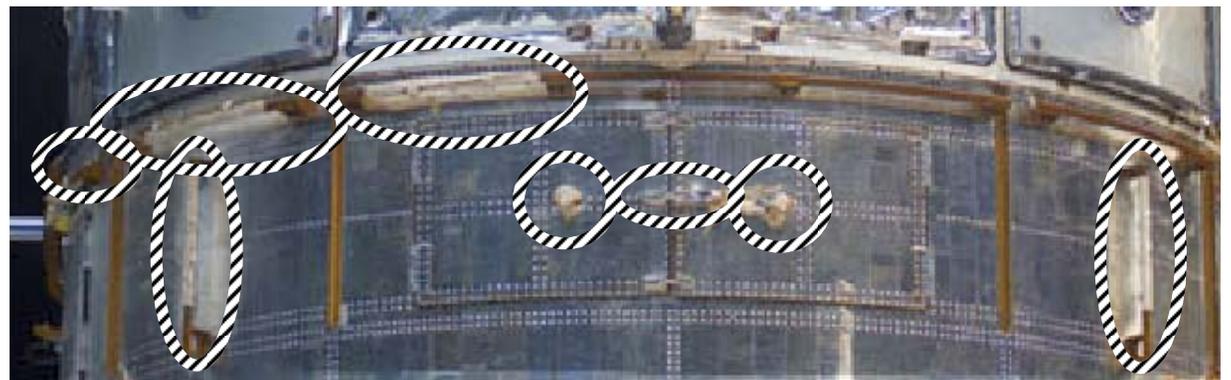
- Handrail Paint:
  - Silicone overcoat on top of polyurethane paint with inorganic pigment
- Free pigment
  - Atomic oxygen (AO) undercuts silicone, erodes binder
  - Pigment left on surface and transfers to gloves when touched
  - Occurs all around telescope
- Flaking (peeling, scaling, lifting; not discoloration)
  - UV + AO damage shrinks silicone
  - Good bond between silicone and paint;
  - Failure between paint and aluminum
  - Occurs with high solar exposure (+V3)

## Mitigation Techniques

- Flight rules
- Glove inspection prior to opening of Aft Shroud
- Contamination covers if necessary
  - Installed on SM3A
    - 5 handrail covers
    - 2 knob covers
    - 1 handle cover
